# **Winter Bridging Exercise on Thick Ice**

## **Fort McCoy, Wisconsin, 1988**

# Special Report 90-10

**U.S. Army Corps  
of Engineers**  
Cold Regions Research &  
Engineering Laboratory

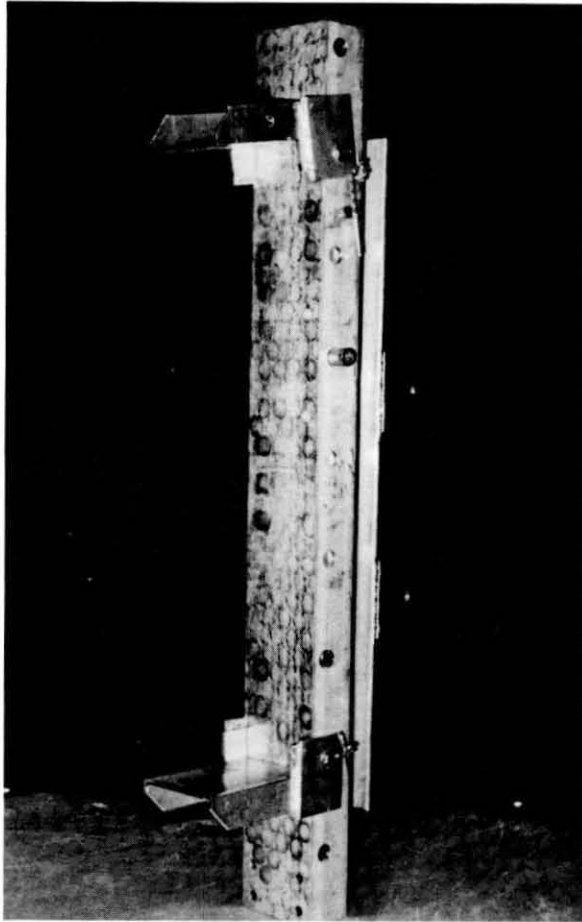
Figure 1. Ice push knees fabricated for the prop-driven Combat Support Boat.

CRREL-fabricated push knees for the Combat Support Boat (Fig. 1) were supplied to be evaluated for pushing floating ice out of the crossing zone. These push knees were designed to fit on the older style, prop-driven Combat Support Boat, but if they worked they could be easily modified for the newer MKI and MKII versions. Additionally, we brought to the test site timber tongs, ice tongs (Fig. 2) and a short aluminum I-beam with a shackle attached (Fig. 3) to use when lifting ice with a transporter boom.

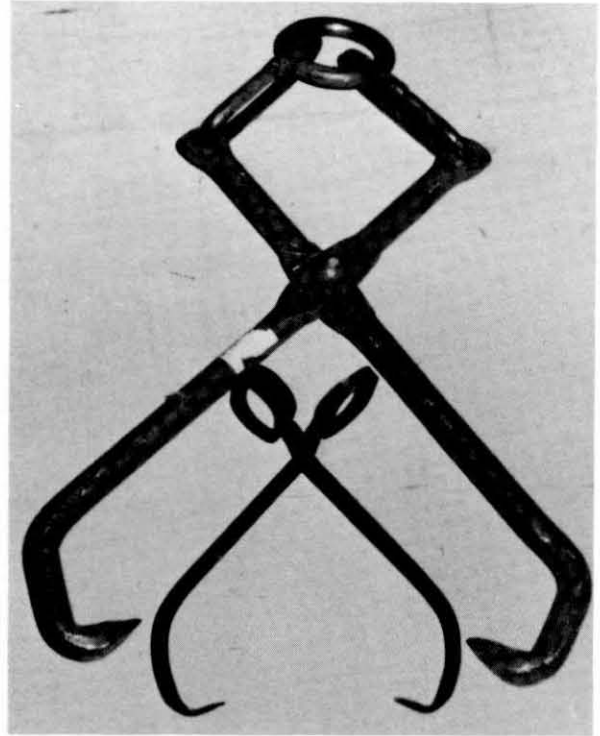
Figure 2. Small hand-held ice tongs inside large timber tongs.

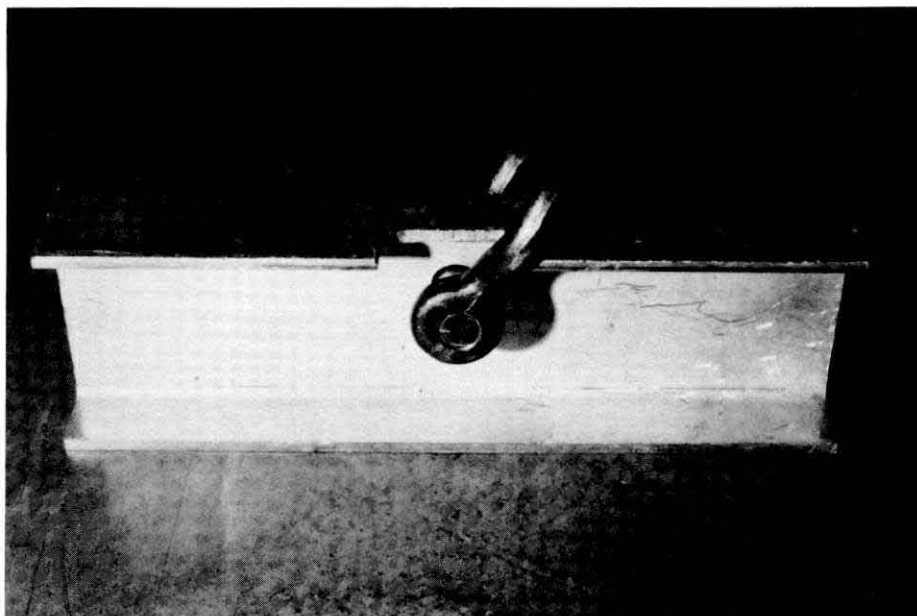
Figure 3. I-beam and shackle used for lifting ice blocks from the water.

Next, we tried using the transporter to remove ice blocks cut by chain saws. The ungrounded ice away from the shore was marked off into approximately 5- x 8-ft sections. Any grounded ice near shore can remain in place and be used as the shore itself when deploying a bridge. Each section had a rectangular lifting hole outlined, off-center, towards the shore end of the section (Fig. 6). It was sized to allow the aluminum I-beam and shackle, with the cable from the transporter boom attached, to be lowered through it. Once under the ice, the I-beam was rotated 90°. This prevented the I-beam

from slipping back out the hole and created a convenient way of lifting an ice section.

After a section of ice had been cut free, a cable was attached onto the I-beam's shackle. The beam was then dropped through the lift hole and rotated to lock it in place. Sections of ice weighing over 5000 lb were lifted by the transporter trucks using this method. Setting the lifting hole off-center allowed the ice block to rotate and lay flat against the transporter boom as it was raised (Fig. 7). The boom would then be lowered and the ice would come to rest on the back of the truck, ready to be carried away. This proved to be a quick and very neat method of ice removal. By use of this technique, the approach to the crossing area can be kept clear of ice. It will also work in areas where there is only a narrow approach to the crossing zone, since it does not require lateral movement of equipment as in bulldozer operations. The trucks

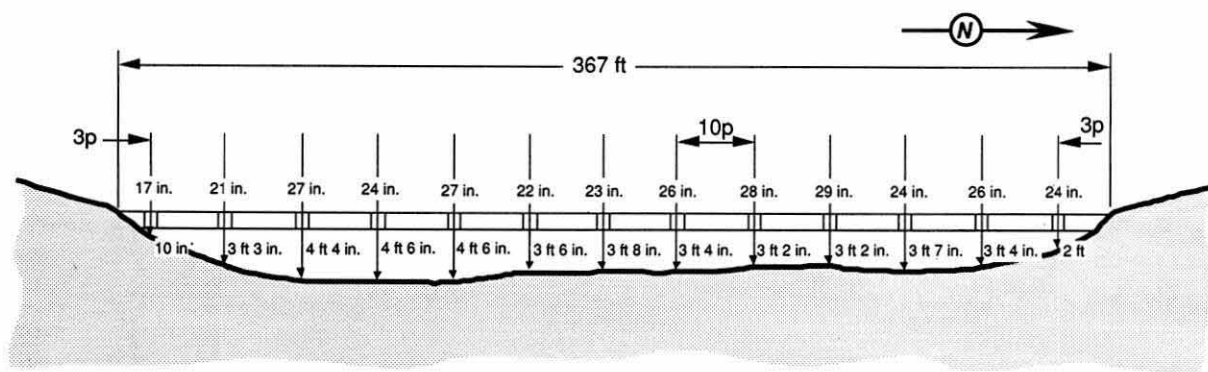
Figure 4. Profile of Alderwood lake on 10 February 1988 (p = paces; values above the ice are ice thickness; values below the ice are depth below the ice cover).

The crossing zone was on Alderwood Lake, at Fort McCoy, Wisconsin. Figure 4 shows the bot-

tom conditions and ice thickness from an ice reconnaissance by Company A 10 days before the exercise. The ice thickness varied from 17 in. in one spot at the south shore to 29 in. at one spot near the north shore of the lake. The weather may have moderated between the time of this reconnaissance and the exercise date, as the thickest ice that was measured during the exercise was 24–25 in.

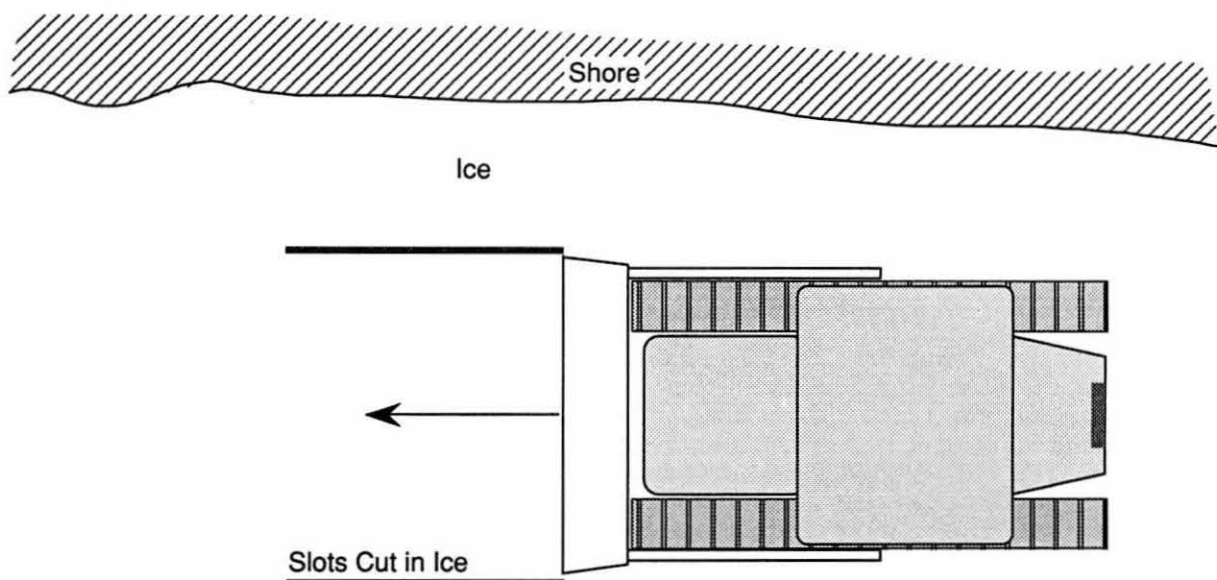
Figure 5. Ice removal by bulldozer. Slots were cut parallel to the bulldozer's direction of travel and just outside the edges of the blade.

the width of the bulldozer blade (Fig. 5). We hoped that these would weaken the ice enough so that the dozer blade could break out sections of ice. A V-notch was then cut into the ice, perpendicular to the working axis of the bulldozer, connecting the previously cut slots, to give the blade a purchase in the ice. In the initial attempts to lower the blade

into the notch, we discovered that the blade support arms contacted the ice surface behind the blade, preventing us from lowering the blade enough to get it under the bottom edge of the ice in front of it. Several attempts to lift the ice failed because the blade would ride up over the ice, scraping off a small amount at the surface. A notch

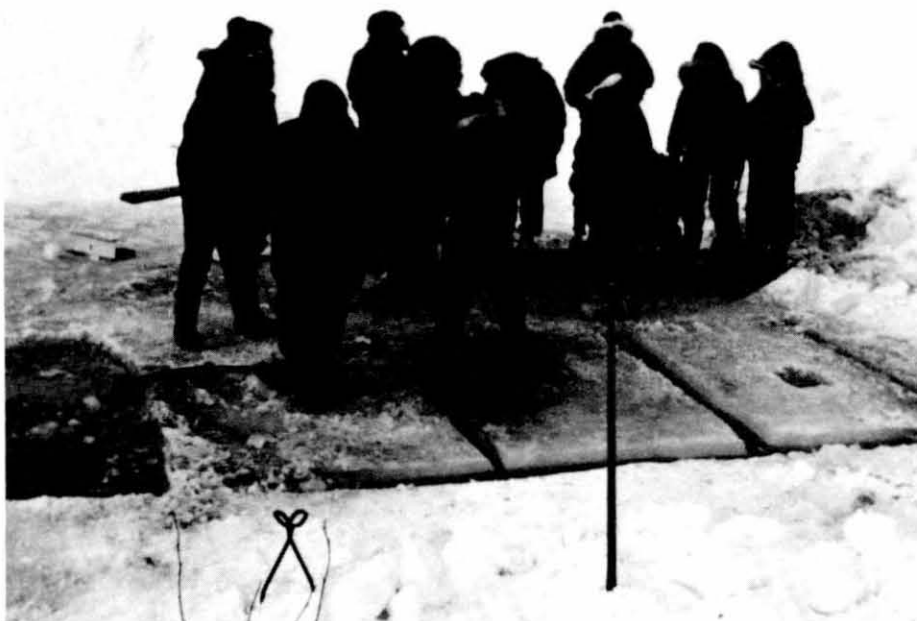
Figure 6. Ice cut into three sections, showing the lifting hole in the righthand block.

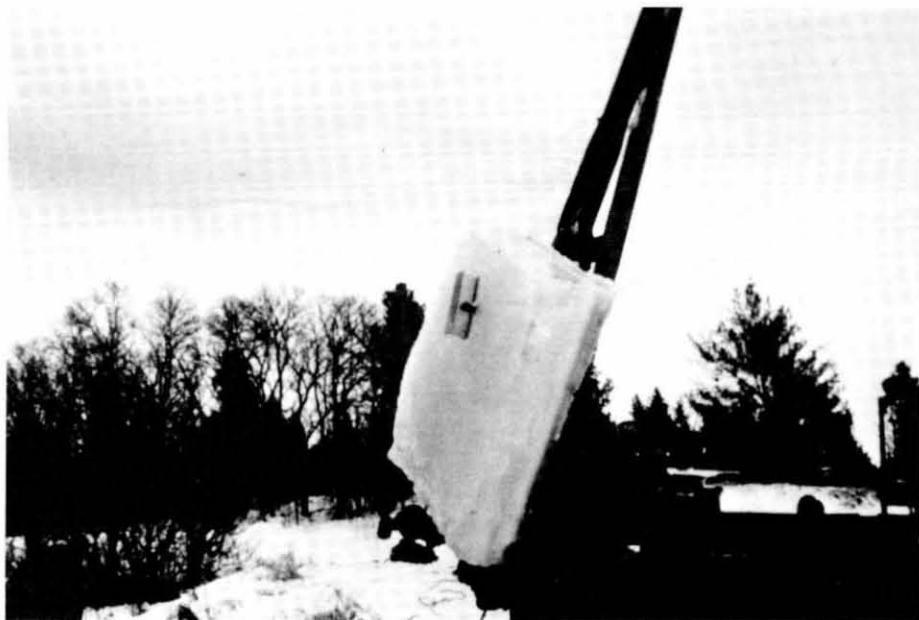
*Figure 7. Ice block lifted by a transporter and being laid against the boom as it is lowered to the cradle.*

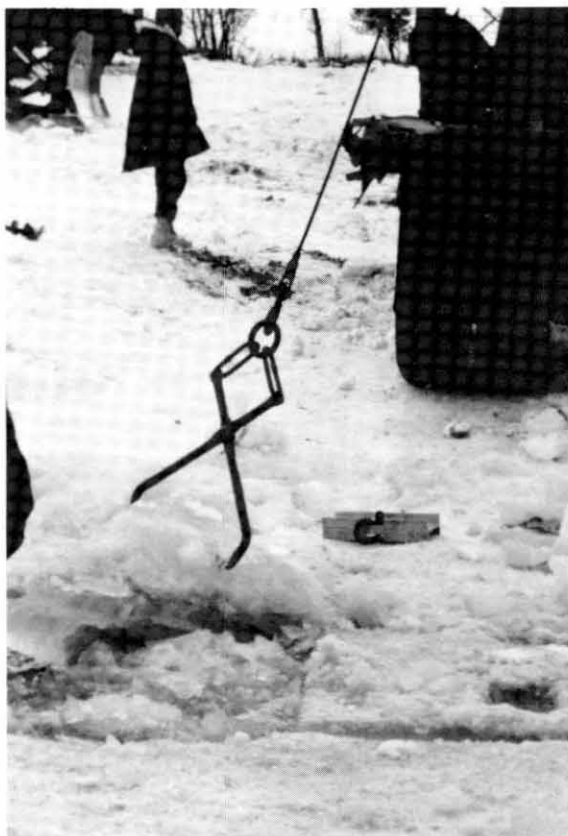
*Figure 8. Lifting ice blocks with timber tongs. The edge of the ice shown here has already spalled off once from a previous attempt to lift it using the timber tongs; the points of the tongs are only gripping at the edges of the ice.*

We also experimented with using a pair of timber tongs to lift the ice blocks. These proved difficult to use because they were not wide enough to fully grip the thick ice that we were handling, except at the very edge of the block (Fig. 8). This frequently resulted in the ice block breaking apart at the edge as it was lifted. We did remove some moderate-sized blocks from the water, but found it took several attempts before the procedure was successful. Properly designed and sized ice tongs could potentially speed up the removal process by eliminating a lifting hole. It can be difficult, however, to attach tongs to a large, horizontal block of ice floating in water.

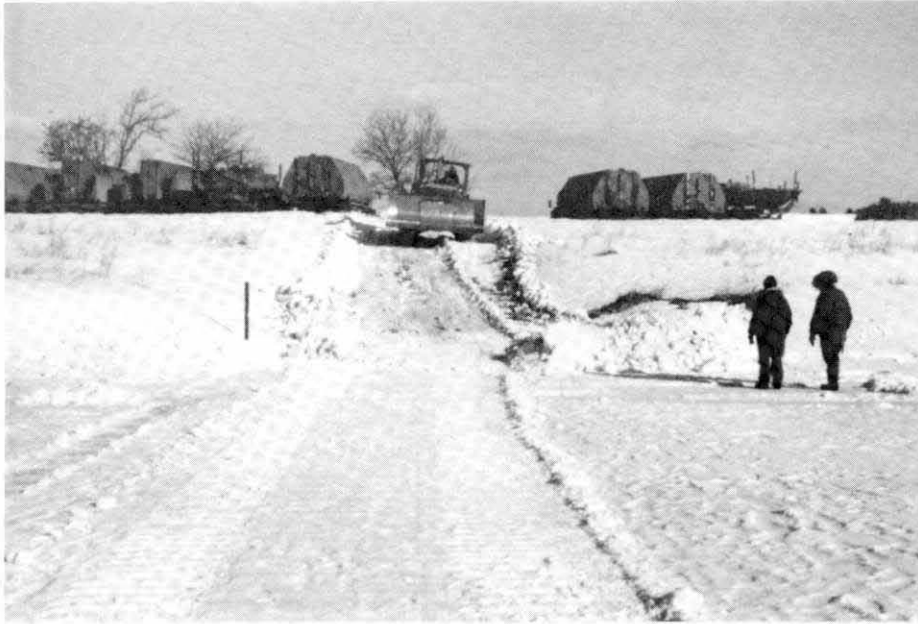
*Figure 9. Bulldozer clearing the snow from the north side of the crossing lane at Alderwood Lake.*

The snow on the approach to the crossing zone and on the north end of Alderwood Lake was cleared away by bulldozer in preparation for the deployment (Fig. 9). The ice was cleared to avoid having snow build up between the pontoons as the bridge unfolds, thus keeping the pontoons from opening fully (Fig. 10).

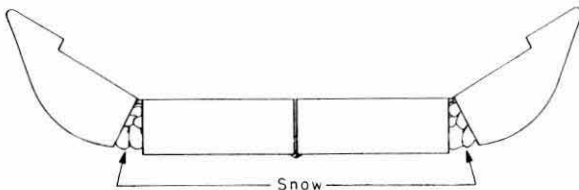
*Figure 10. Snow buildup between the bow and roadway pontons can prevent the pontons from being latched.*

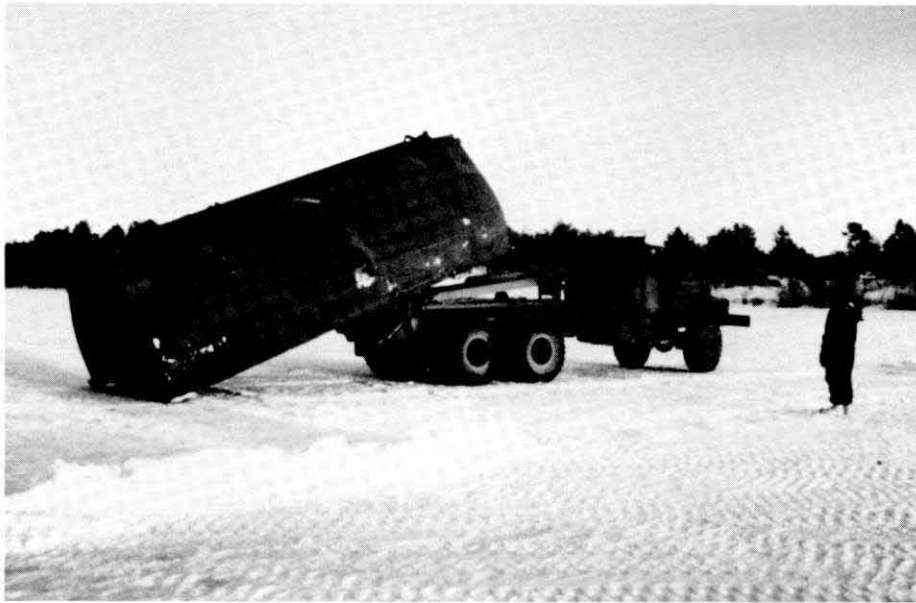
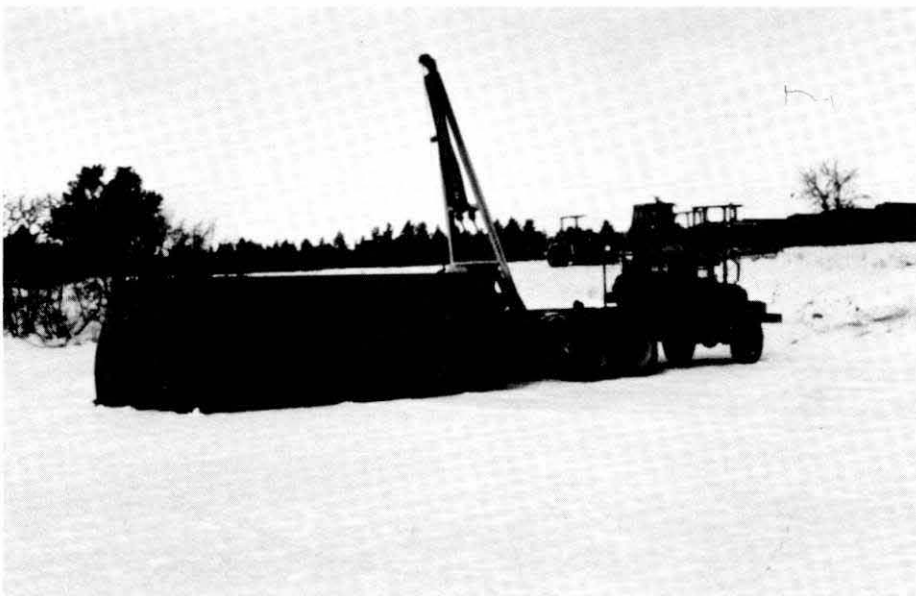
*Figure 11. Deploying an interior bridge bay section.*

*a. One end of the interior bay is slowly lowered off the truck to the ice.*

*b. The remaining end of the bay is attached to the transporter boom and lowered off the truck to the ice surface.*

The first section deployed was an interior bay. It was placed on the ice in the same manner as the bays would be placed in a maintenance yard. The transporter was positioned on the centerline of the crossing zone and the cradle was raised to gently lower the rear end of the interior bay onto the ice.

The transporter boom was then used to steadily lower the opposite end onto the ice (Fig. 11).

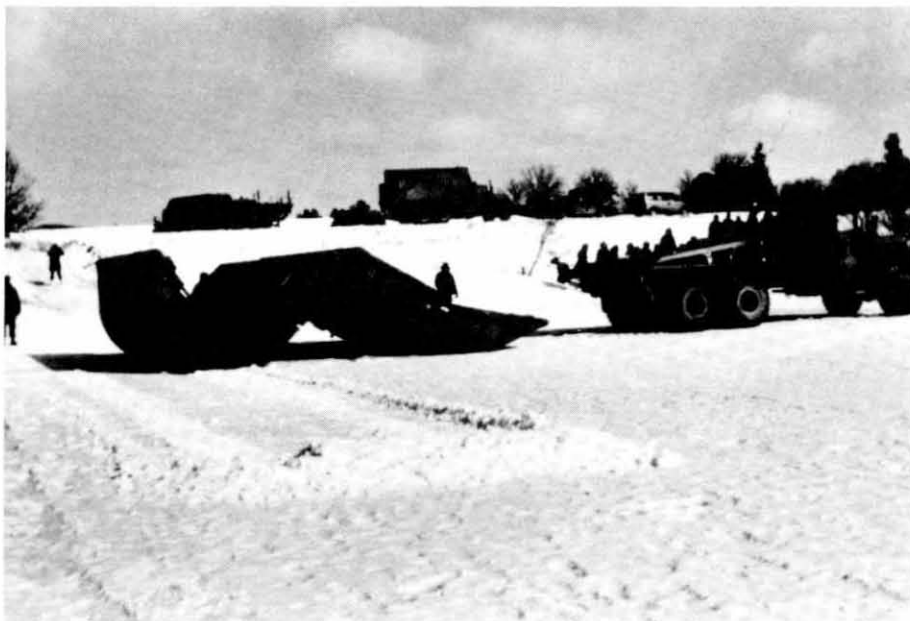
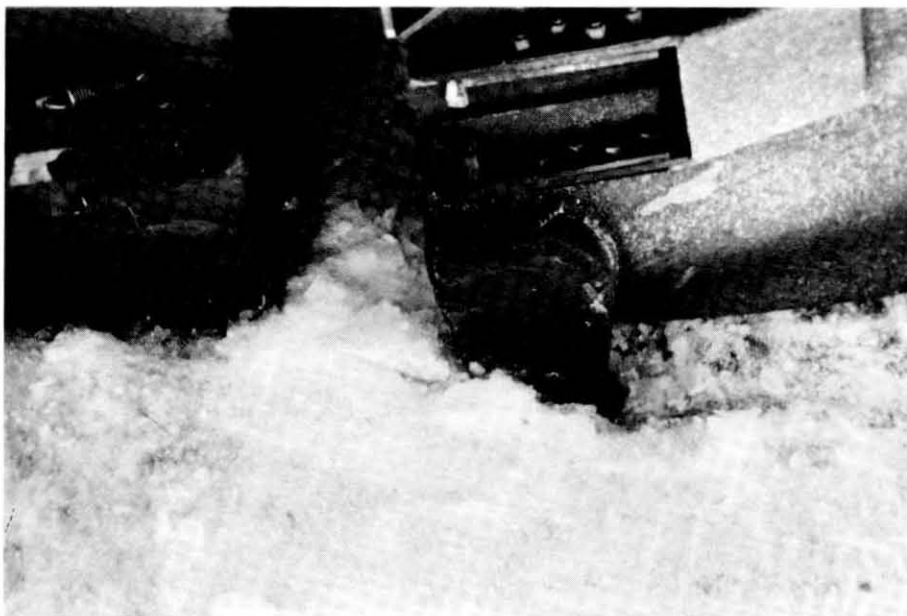
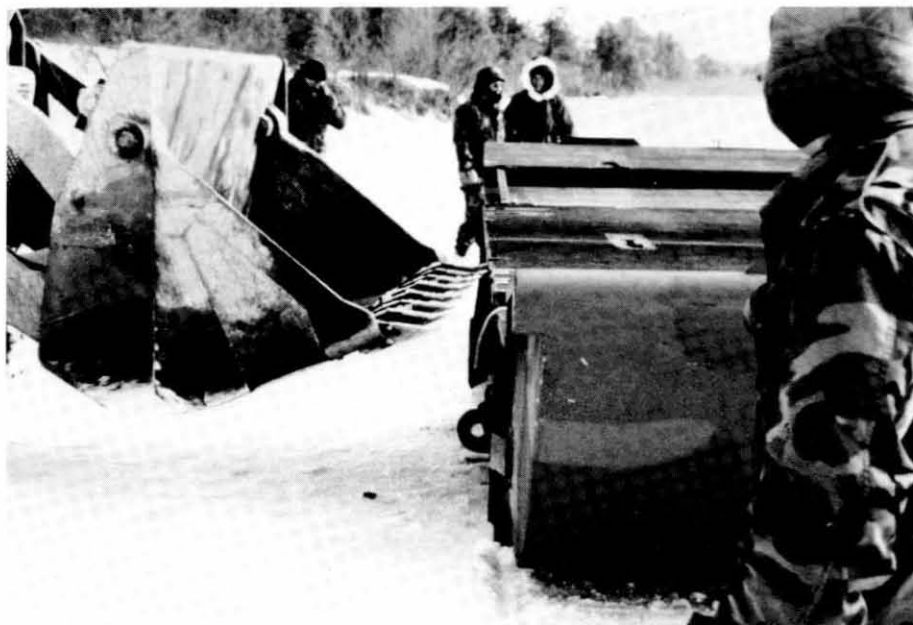
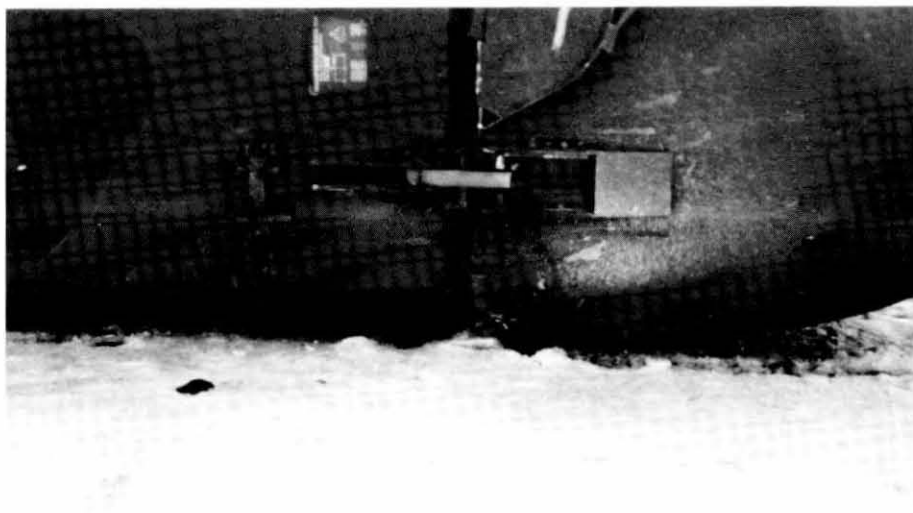
*Figure 12. Opening a bridge bay.*

*a. The cable from the transporter slowly pulled the bow ponton to start the bay unfolding.*

*b. The tiedown pins on the bow pontons would dig a groove in the ice, sometimes preventing the ponton from rotating into its fully opened position.*

*c. The bulldozer blade was used to carefully lift the bay to allow the bow ponton to swing into position.*

*d. Fully closed bow ponton latched into position. Note the groove in the ice left by the tiedown pin when the ponton rotated downward.*

The bay did not unfold by itself as it would in a water launch and therefore had to be coaxed into opening. A transporter was moved around to the side of the bay where its cable was attached to a bow ponton. The truck then drove slowly away from the bay, pulling the bow ponton down, which unfolded the bay (Fig. 12a). However, the bow pontons did not unfold completely, as the tiedown pins prevented the ponton on one side from rotating fully into position (Fig. 12b). A small bulldozer was positioned at one end of the bay and used its bucket to lift one end of the bay up at a roadway ponton (Fig. 12c). This lifted the tiedown pin up out of the groove it had dug in the ice (Fig. 12d) and allowed the bow ponton to swing into place at both ends.

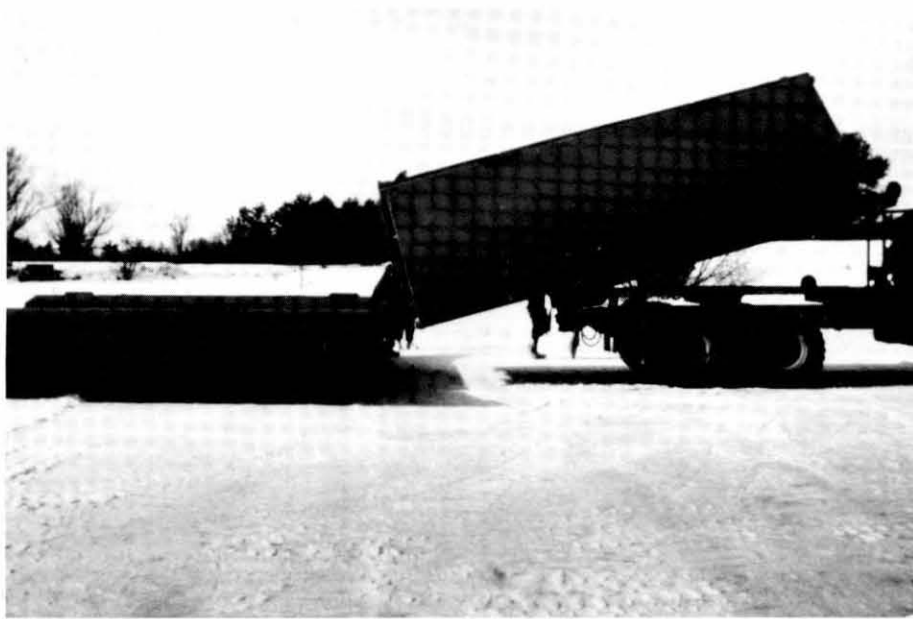
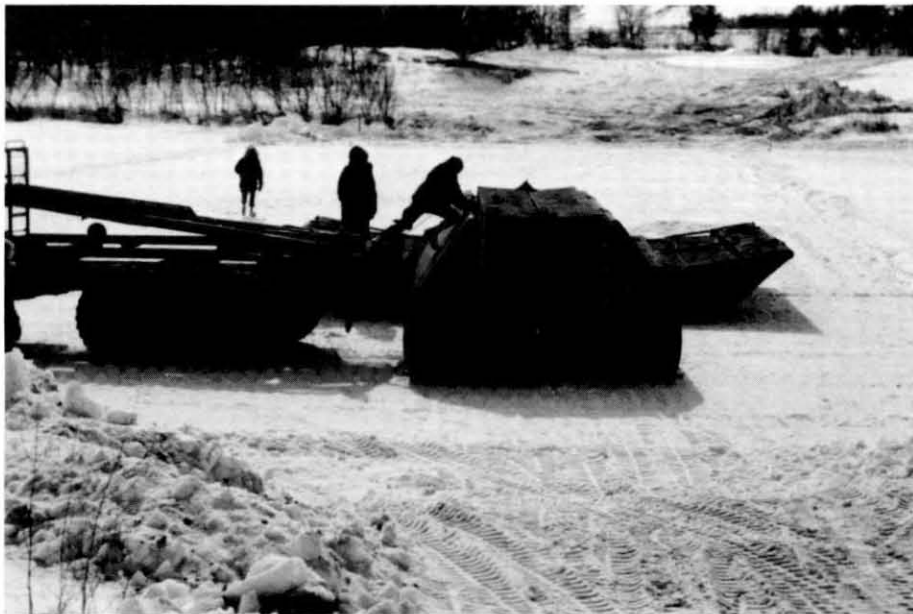
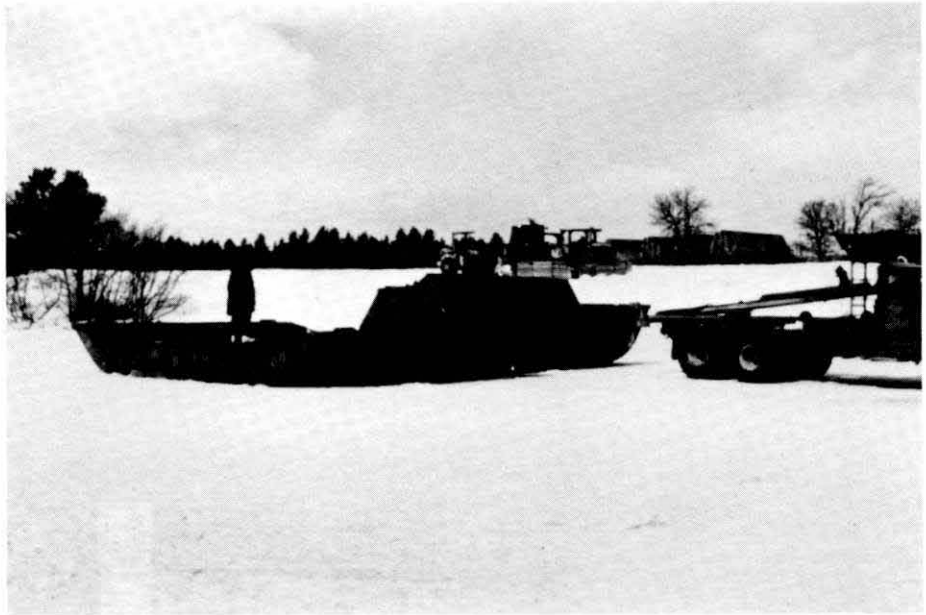
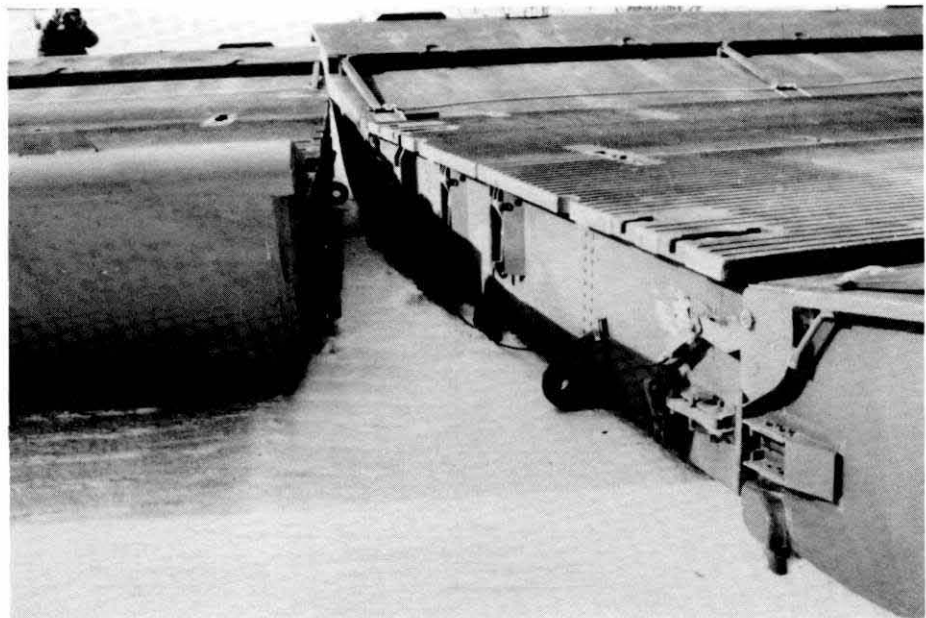
*Figure 13. Opening a second bridge bay.*

*a. The second interior bay was unloaded in line with the first.*

*b. A transporter was again needed to start the bay unfolding.*

*c. The bay unfolding as the transporter is pulling the bow ponton.*

*d. The bay jumped out of alignment from the inertia of the pontons falling into their open positions.*

The second bridge bay was unloaded in line with the first and pulled open using a transporter (Fig. 13). However, the section jumped out of alignment as the pontons unfolded (Fig. 13d), and a cable pulled by the bulldozer was used to slide the section sideways back into alignment with the first. The roadway pontons opened fully but, as before, the bow pontons on this section did not unfold completely. In this case the roadway pontons were latched into place and a transporter and its boom were used to lift the end of the bay up to allow the bow pontons to rotate into place. The

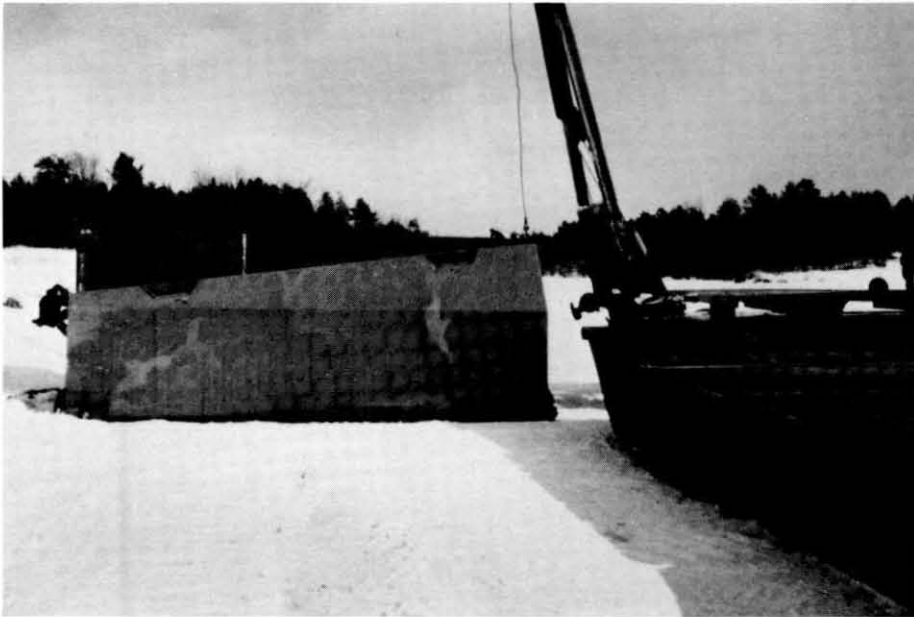
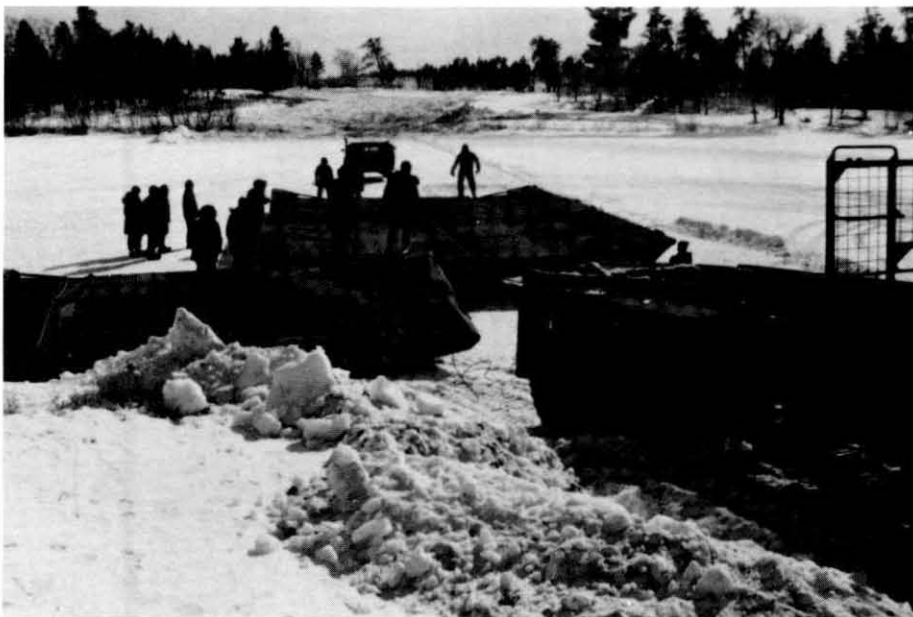
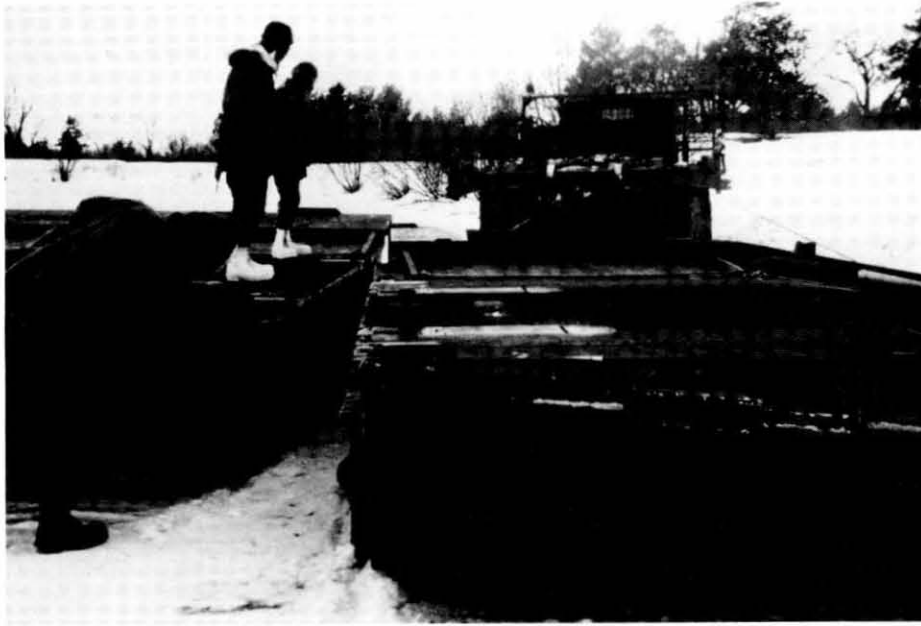
*Figure 14. Deploying the ramp section.*

*a. The ramp was unloaded alongside the last interior bay.*

*b. A transporter was used to align the bay with the previously placed sections.*

*c. Once aligned, the ramp bay was moved sideways into position at the end of the interior sections.*

centerline between the last roadway section and the shore. It was unfolded by the same technique as the roadway pontons, with both bow pontons requiring an assist from a transporter to unfold. Once unfolded with its pontons locked in place, the ramp bay was moved sideways into position by a transporter (Fig. 14).

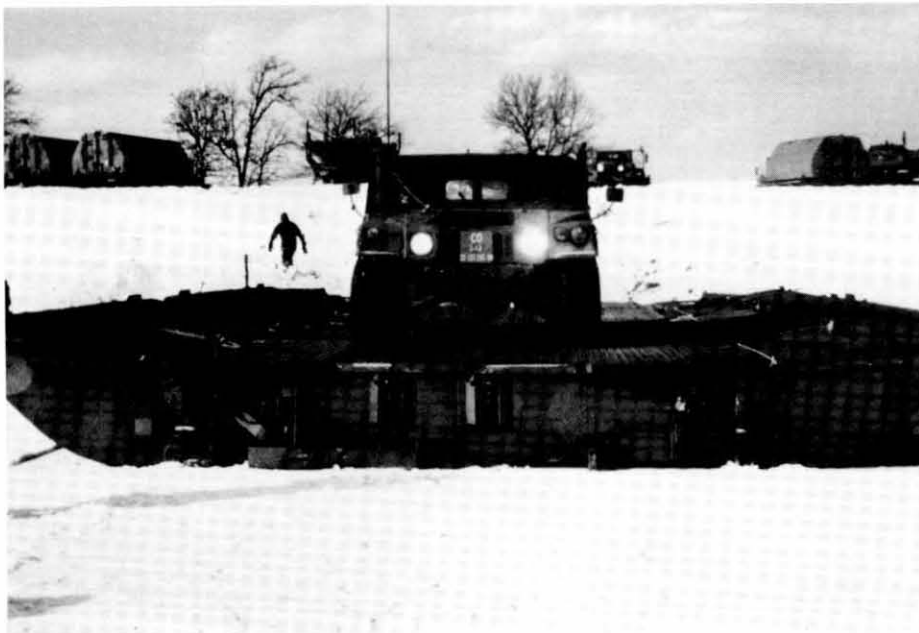
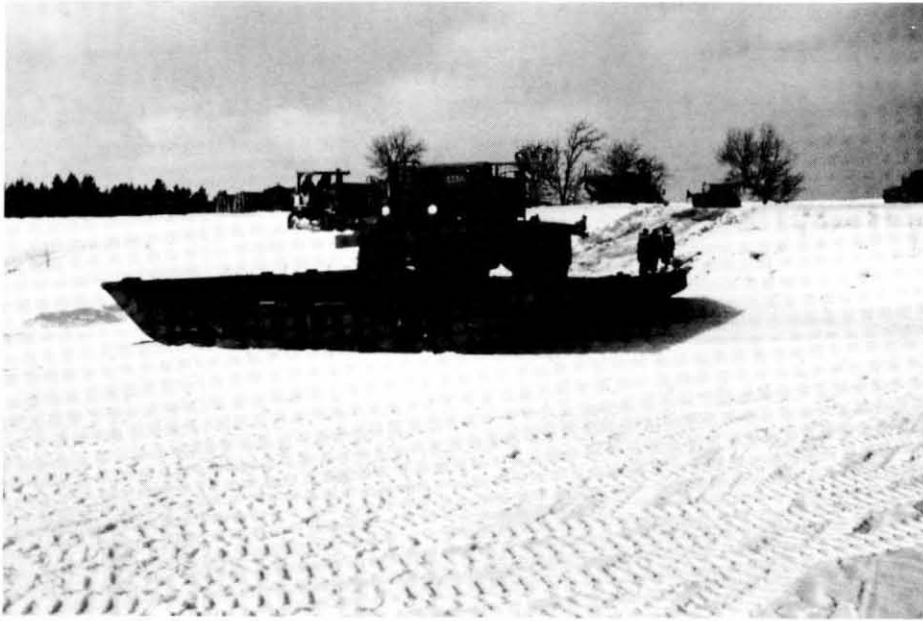
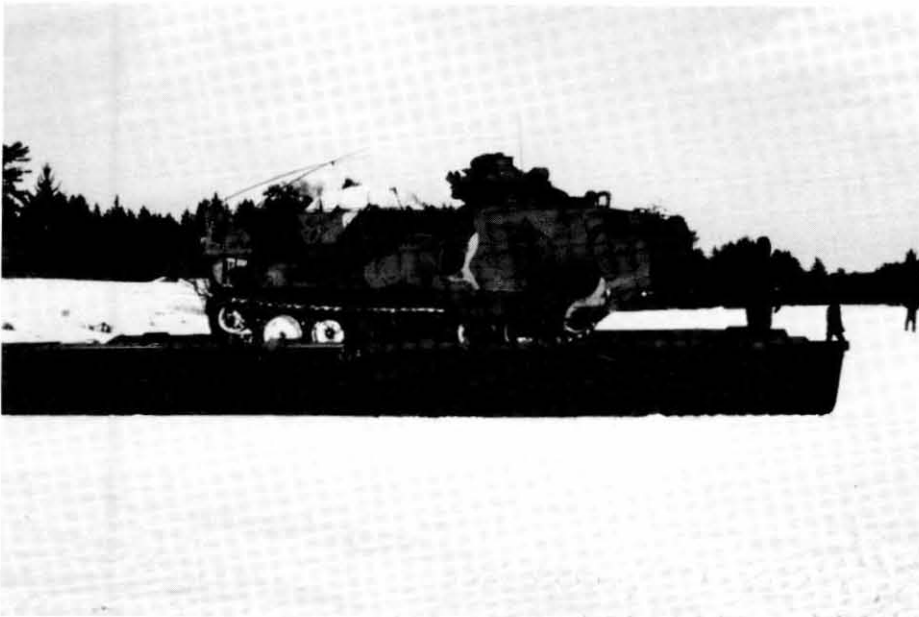
*Figure 15. Loads applied to the assembled bridge bays.*

*a. HMMWV.*

*b. Transporter.*

*c. AAV.*

within approximately 3 to 4 in. This was more than close enough to provide an essentially continuous surface for travel between the sections, but it did not allow the bays to be locked to each other. A HMMWV (class 4), transporter (class 28) and an AAV (class 26) were driven onto and off from the sections individually to determine the reaction of the bays and ice to the loads (Fig. 15).

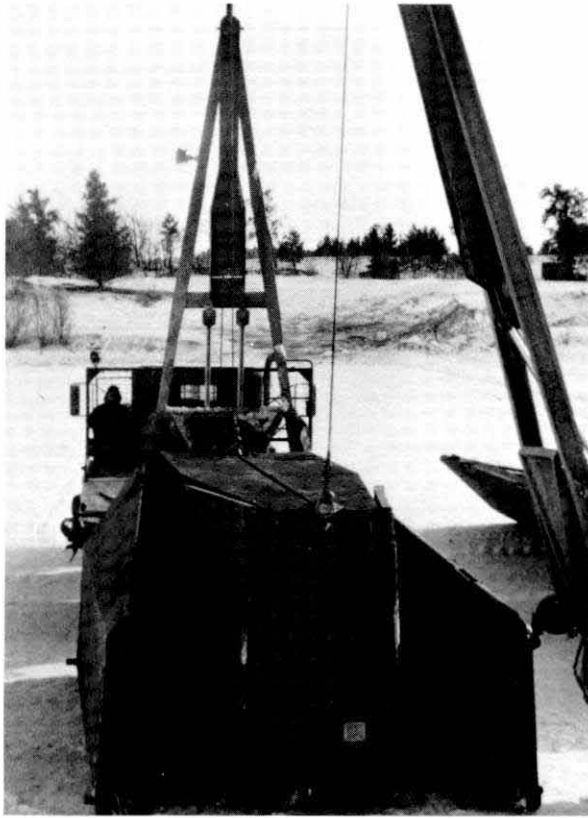
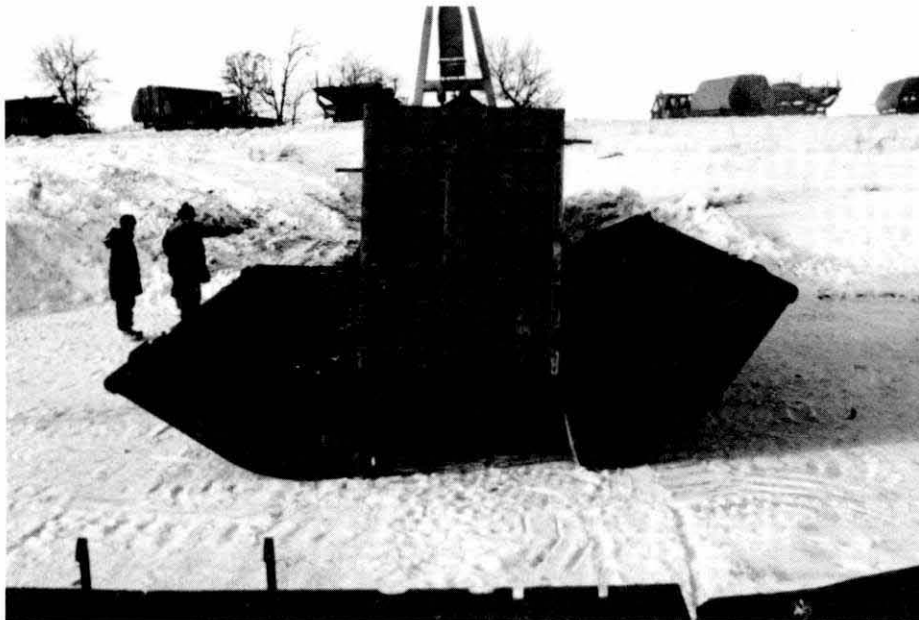
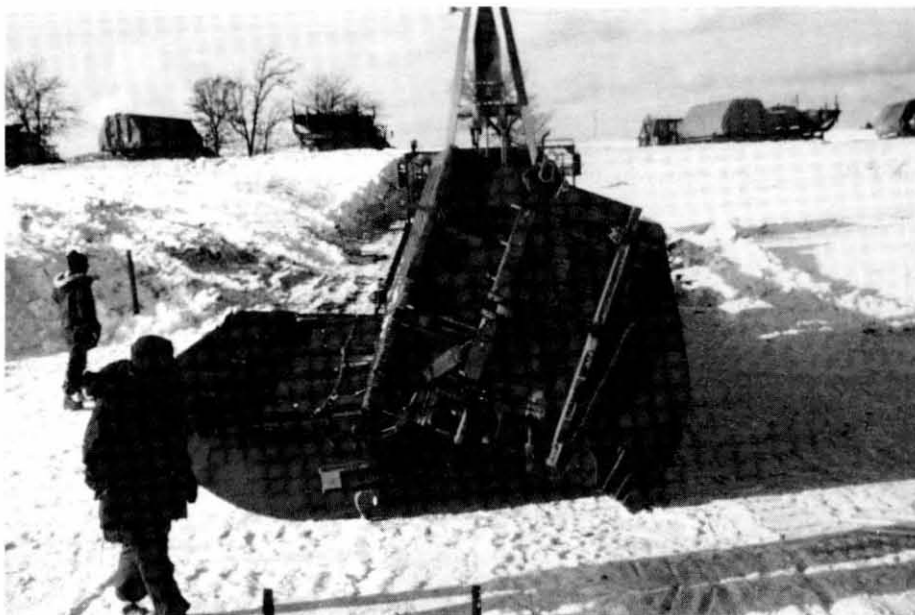
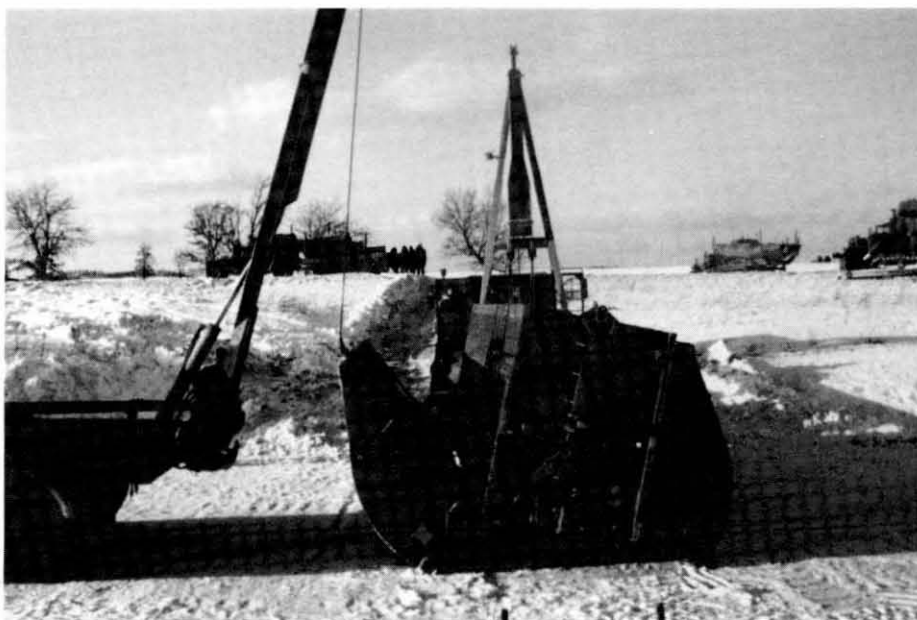
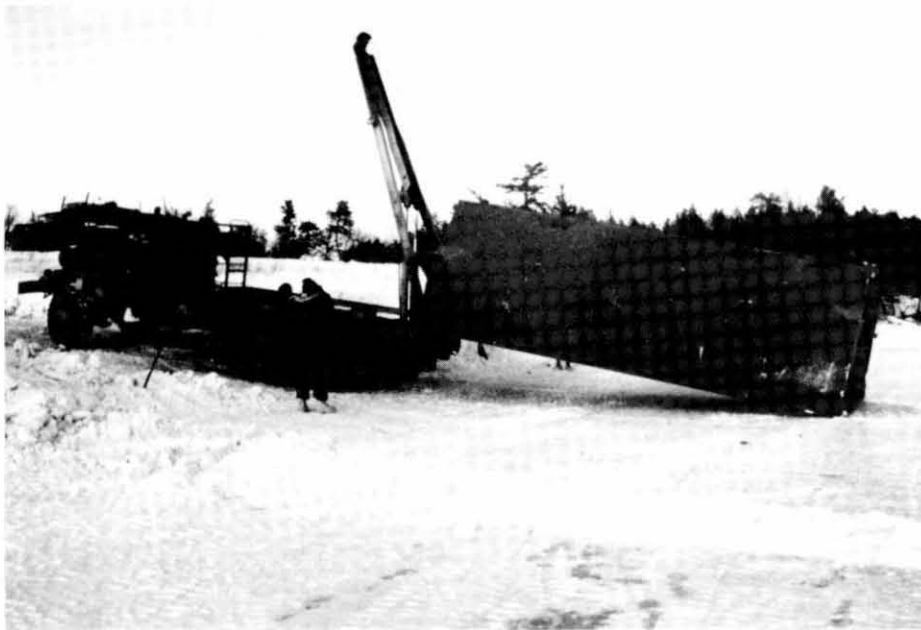
*Figure 16. Retrieving the bridge.*

*a. The ramp bay with both transporters attached. Lifting up both ends of the bay allowed the bow pontons to rotate closed.*

*b. As the interior bay was initially lifted to the transporter, both bow pontons failed to rotate closed.*

*c. One bow ponton was coaxed closed by cycling the bay up and down.*

*d. The second bow ponton was closed by lifting it with a second transporter.*

*e. Once closed, the bay was routinely loaded onto the transporter.*

To retrieve the bays, we reversed the deployment sequence. A transporter slid the ramp bay sideways away from the interior bays. It then backed up to the end of the bay and lifted it with its boom, as in a normal recovery. One bow ponton did not fold up into its travel position as the bay was raised up to the truck. So, a second transporter backed up to the ponton, attached a cable to it and lifted upwards until the ponton folded (Fig. 16a). The ramp bay was then loaded onto the transporter.

The first interior bay was loaded from the end closest to shore and thus it was not necessary to slide the bay sideways away from the remaining section. Both bow pontons on this interior bay failed to fold up during the initial lift to the transporter. One ponton was coaxed into closing by raising and lowering the end of the bay with the transporter (Fig. 16b and c). It was necessary to use a second truck to lift the remaining ponton, similar to the procedure used on the ramp bay ponton, to rotate it into its travel position (Fig. 16d). The bay was then loaded onto the transporter in a relatively straightforward procedure (Fig. 16e).

Both of the bow pontons on the remaining interior bay refused to fold up during the initial lift and had to be individually lifted by a second trans-

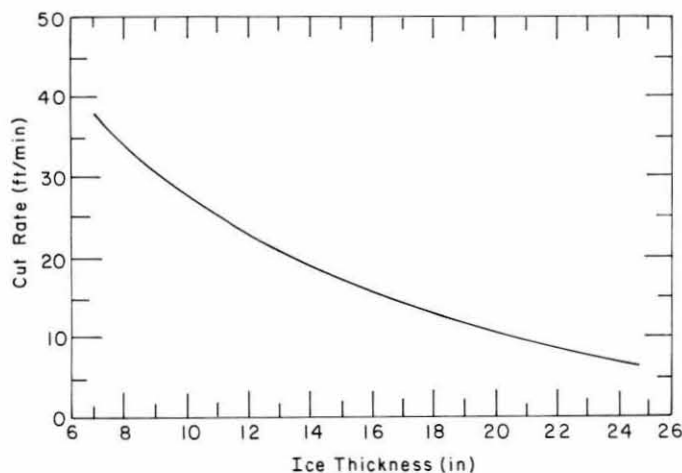
*Figure 17. Cutting rate vs ice thickness using a 24-in. chain saw with a skip-tooth blade modified for ice cutting (after Coutermarsh 1989).*

Removing thick ice from a crossing zone can be very labor intensive and time consuming. Figure 17 is a graph of cutting rate vs ice thickness attained with a 24-in. chain saw and a chain modified for cutting ice. As the ice thickness increases, the cutting rate attainable with chain saws falls exponentially. It is evident that cutting the ice

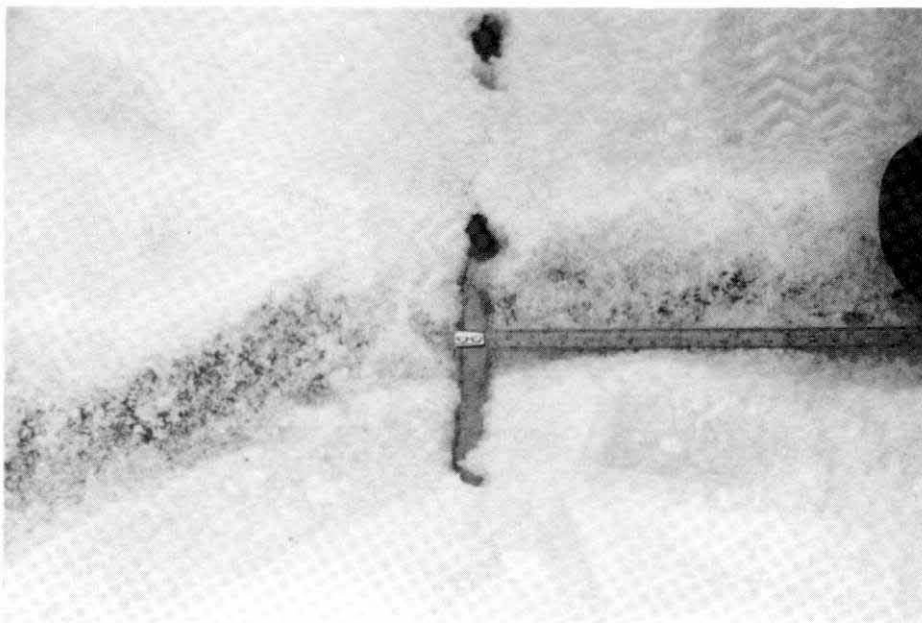
Figure 18. A portion of one of the  $\frac{1}{2}$ -in.-wide circumferential cracks that developed in the ice around the Ribbon Bridge.

During the deployment sequence, the ice developed radial cracks originating from the area where the bridge sections were placed (Fig. 18). Not long afterwards, what appeared to be portions of two

circumferential cracks also appeared, centered around the bridge sections. The closest crack was about 10 ft from the end bridge section and had a top width of  $\frac{1}{2}$  in. The next crack was about 69 ft from the bridge and it too was  $\frac{1}{2}$  in. wide. The pattern of the visible portion of these cracks suggested that they would form a semicircle around the bridge, but the snow on the ice made it impossible to confirm this.
