# **Winter Bridging Exercise on Thick Ice**

## **Fort McCoy, Wisconsin, 1988**

# Special Report 90-10

**U.S. Army Corps  
of Engineers**  
Cold Regions Research &  
Engineering Laboratory

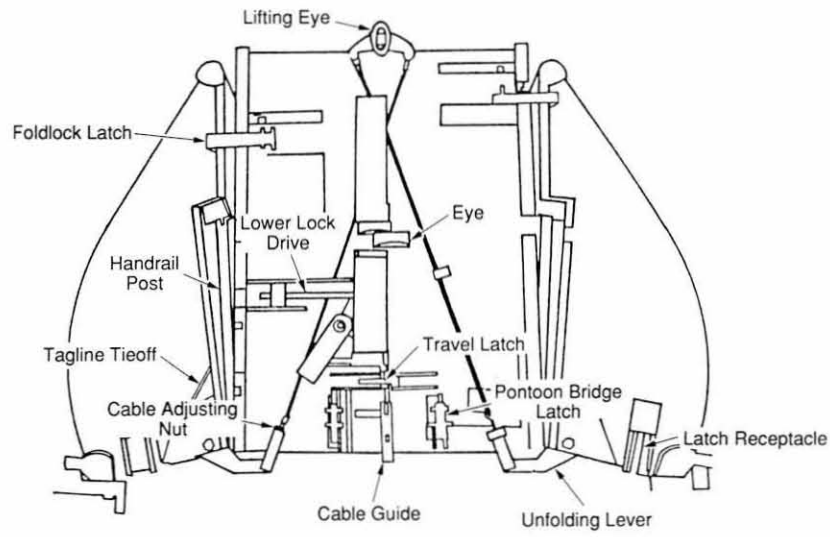
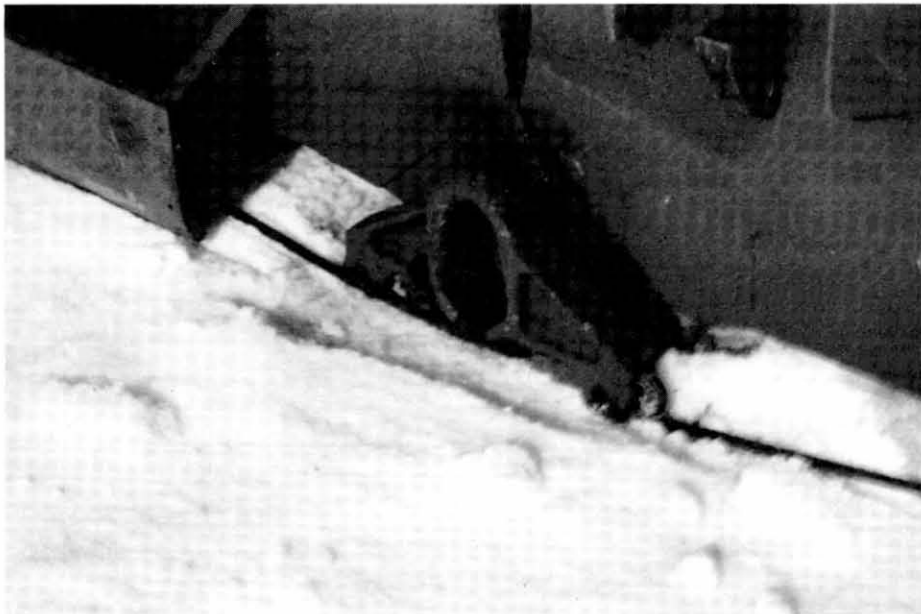
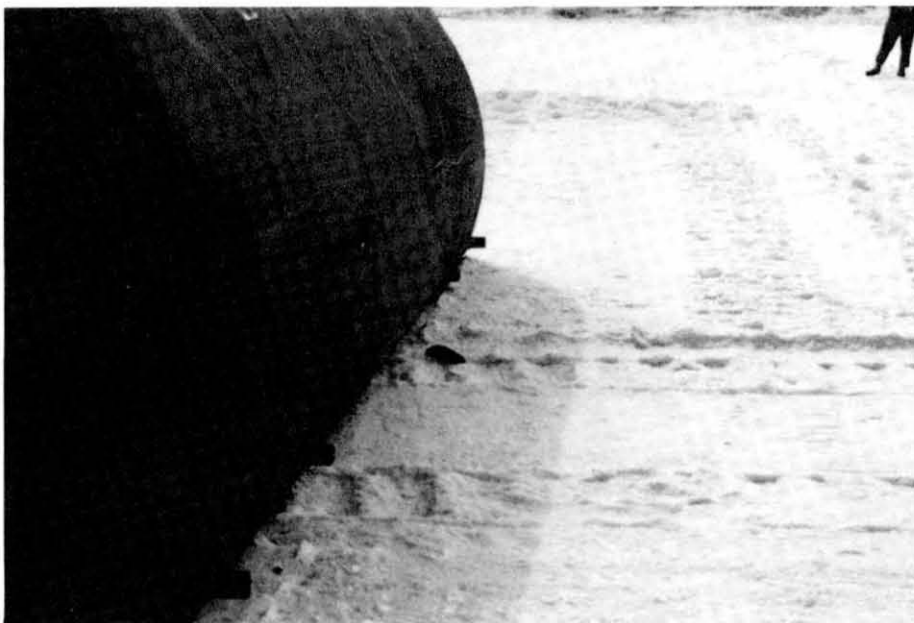
*Figure 19. Potential damage to bridge bay components.*

*a. The pontoon bridge latches should be secured in their travel position, as shown here, before unloading the bay onto the ice (after U.S. Army 1980).*

*b. The bell crank on the bay projects down enough to contact the ice surface with the bay unfolded.*

*c. The folded bridge bay showing the travel lugs projecting out from lower surface of the ponton.*

When the Ribbon Bridge is set on an ice cover, there are some components that might be harmed during deployment or trafficking. When the bays are unloaded, the ponton bridge latches must be pulled up to prevent them from being damaged when the bay contacts the ice (Fig. 19a). These should remain in this position during any subse-

quent positioning of the bay. Figure 19b shows the lifting eye and bell crank for the cables connected to the unfolding levers resting on the ice. The bell crank or its shaft might be damaged by repeated forcing against the ice when the bay is being moved into position or when vehicles use the roadway pontons.

The travel lugs project out from the surface of the bow pontons and therefore take the majority of the load from the bridge when it is resting on a hard surface (Fig. 19c). This will cause a stress concentration in the corner of the ponton where the travel lugs attach to the bow pontons. As shown earlier, dragging a bay into position will cause the lug to dig into the ice (Fig. 12b). This drag resistance from the lug is a major impediment to moving the unfolded bays on the ice and also causes a torque to be transmitted via the lug into the corner. Trafficking the bridge will put a vertical load onto the lug, possibly punching the lug further into the ponton.

A fairing that could be attached to the lugs to prevent them from digging into the ice might be beneficial. The fairings would slide over the ice, reducing the torque transmitted to the corner, and the bays would slide easier because of the reduced drag from the lugs. A fairing would not diminish the punching force transmitted by the lug to the corner unless it could be designed to transmit the

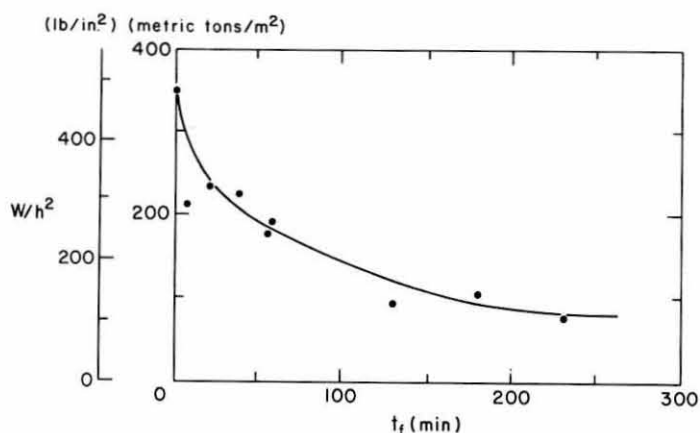
Figure 21. Bearing capacity chart for loads of long duration (from U.S. Army Corps of Engineers 1982).

Figure 21 is a graph from EM 1110-2-1612 (U.S. Army Corps of Engineers 1982) predicting creep failure based upon the load  $P$ , ice thickness  $h$  and the length of time the ice is subjected to the load. This graph is valid for a concentrated load, which may or may not apply to the strip load the ice experiences from a Ribbon Bridge. Experience with this manner of loading is scarce, if it exists at all, and appropriate analysis and confirmation would be needed to obtain a definitive answer.
