A STUDY OF THE EFFECT OF N-BUTYL ACETATE ON A MOTOR AND GEAR REDUCER SYSTEM FOR A DEEP ICE CORING DRILL

Åsa Hagberg, Torbjörn Henriksson

**PICO
TR-90-4**

December 1990

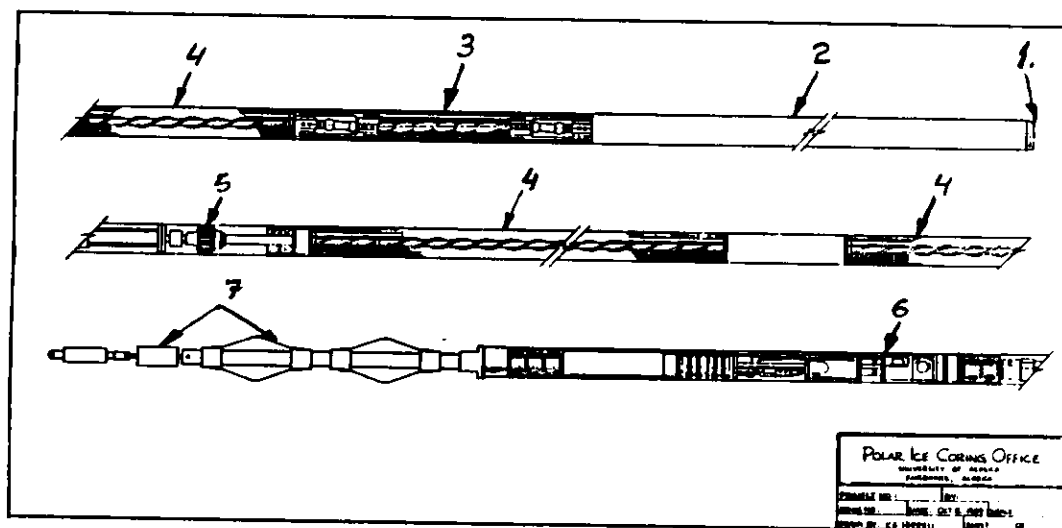
Figure 1. PICO deep ice core drill system.

This drill is an expansion of PICO's 4 inch drill for dry holes. The construction is open, which means all parts of the drill are exposed to the drilling fluid. A schematic of the drill is shown in Figure 1. (3)

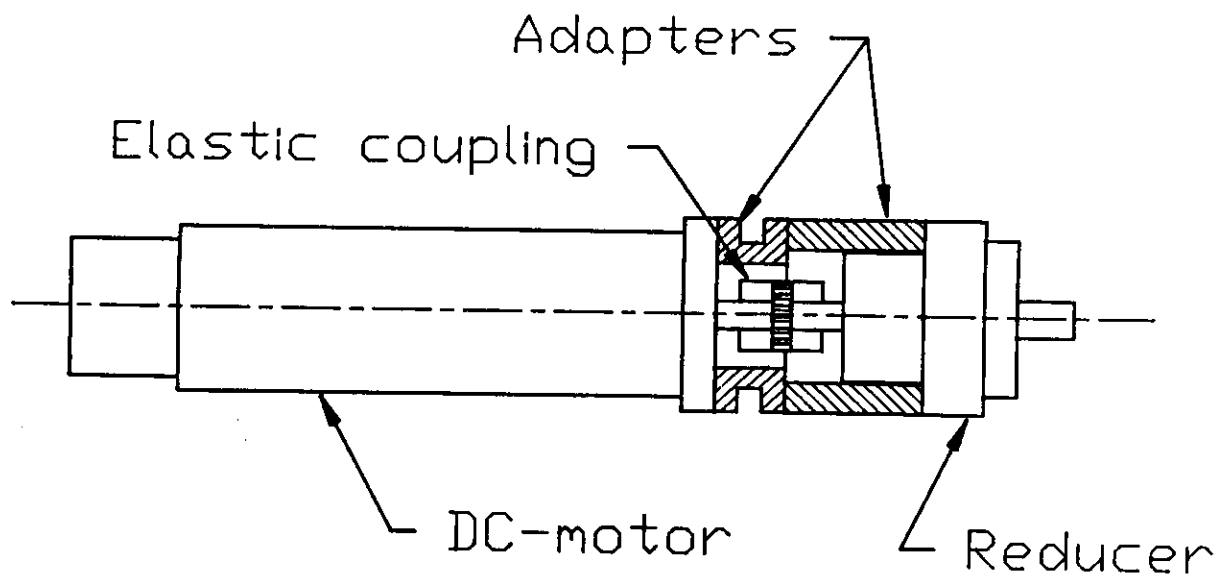
Figure 2. The motor and gear reducer system.

The motor in the drill is a standard DC motor (Appendix 1). Various manufactures have been used. Some of the motors have run for a longer time, while others have broken down after only about 100 hours. There seem to be differences in how well motors from different manufacturers can work in liquids, specially in n-Butyl Acetate.

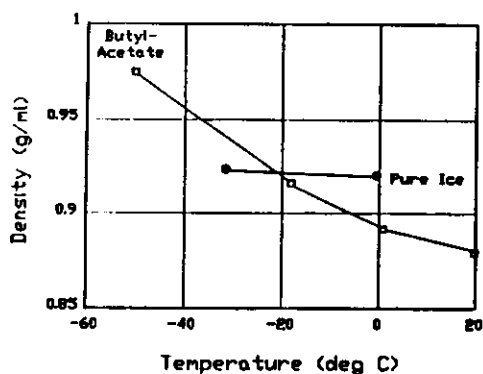
Figure 3. Density of pure ice and n-Butyl Acetate at different temperatures. (1)

When selecting an ice core drilling fluid, the density is of major importance. The fluid is added to the drill hole to maintain adequate pressure in the ice. The hydrostatic pressure is a function of density and depth. The drilling fluid's density must be higher than the density of the ice in order to obtain the necessary pressure. The density of n-Butyl Acetate increases rapidly with decreasing temperature. No densifier needs to be added when the mean temperature in the ice hole is lower than -20°C ; glacier ice is lighter than pure ice due to its high air content (Figure 3). (1)

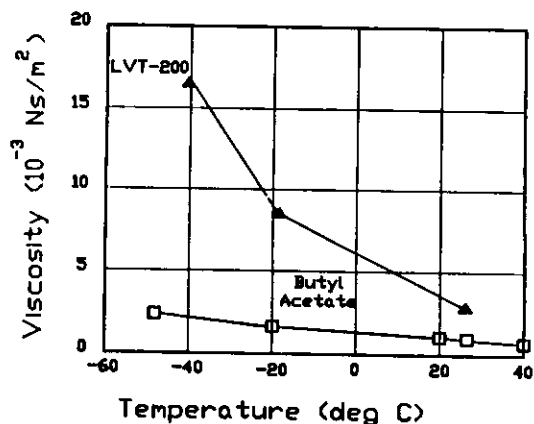
Figure 4. Viscosity of n-Butyl Acetate and another drilling fluid (LVT200 + PBBE) at different temperatures. (1)

A drilling fluid with low viscosity allows drilling of smaller holes. Higher viscosity demands larger diameter holes which require more time and energy. The viscosity of n-Butyl Acetate is about 1-3 cp (10^{-3} Ns/m^2) (Figure 4).

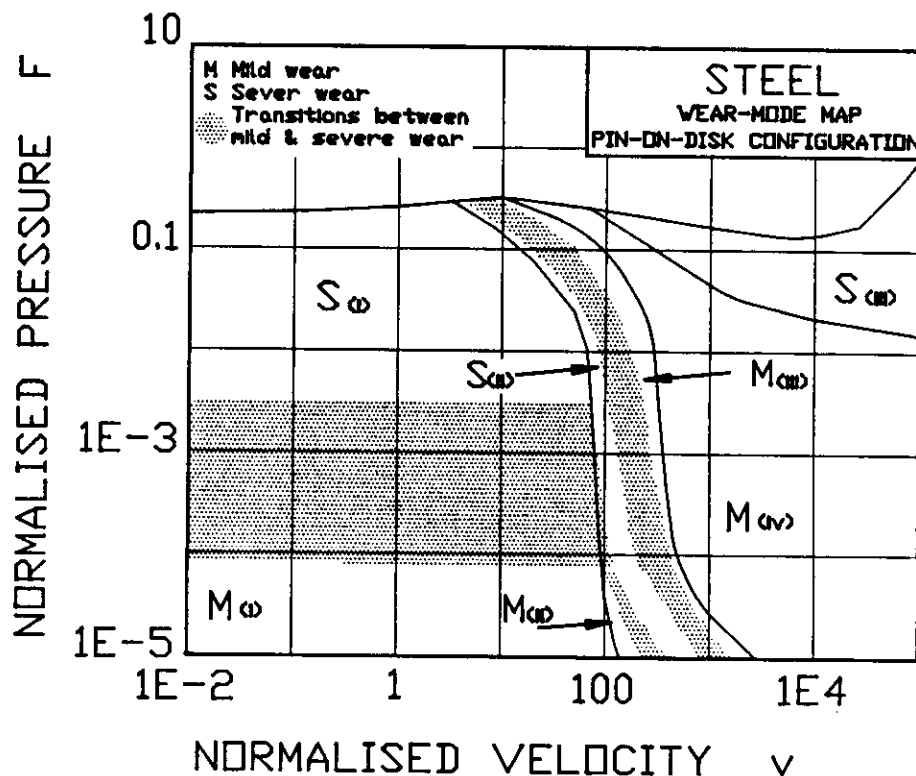
Figure 7. Wear mode map (9,10).

An attempt was made to unravel some of the confusion caused by all these different classifications by naming the wear mode *mild* or *severe* and relating the dominant wear mechanism to normalized data (Figure 7). (9,10) *Mild wear* gives a smooth surface and takes place under four different sets of conditions:

The wear-mode map shows the mode of wear and the dominant wear mechanisms on a diagram with axes of normalized contact pressure and normalized sliding velocity. The map also shows the transitions between the different types of modes. There are three different types of transitions:

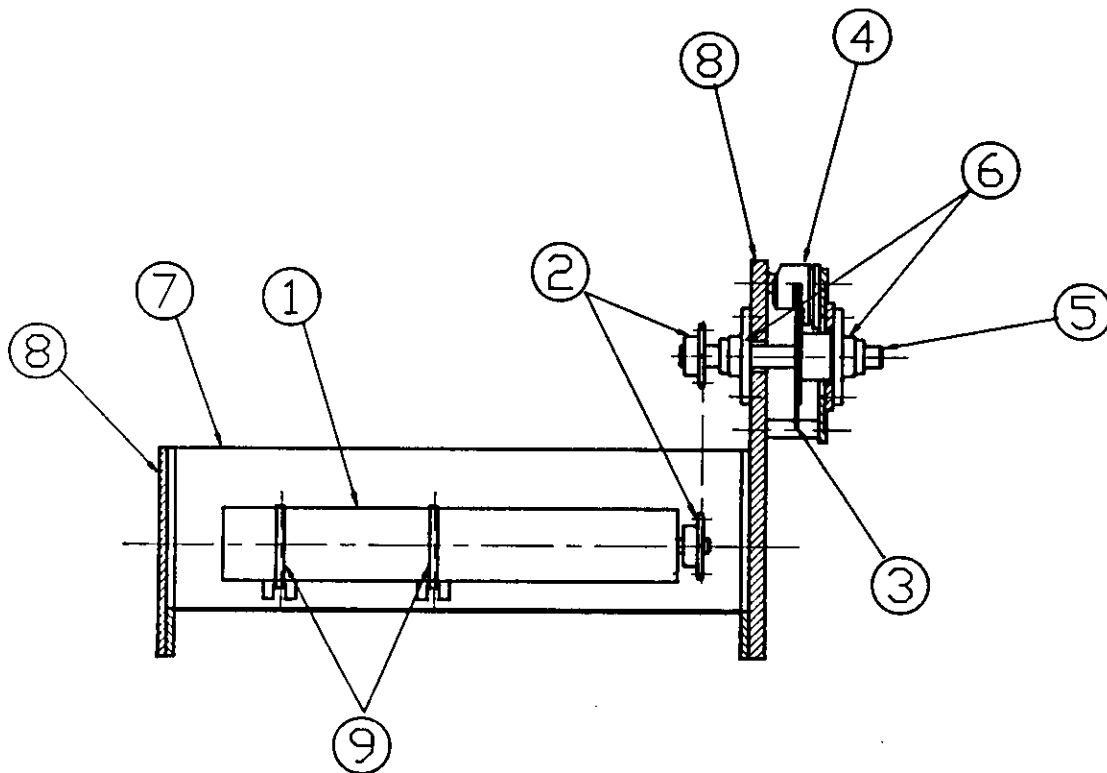
Figure 10. Test stand of the motor/gear reducer system.

systems. An end piece is bolted in each end of the trough and the connections are sealed with cork gaskets. Cork is not affected by n-Butyl Acetate (Figure 10).

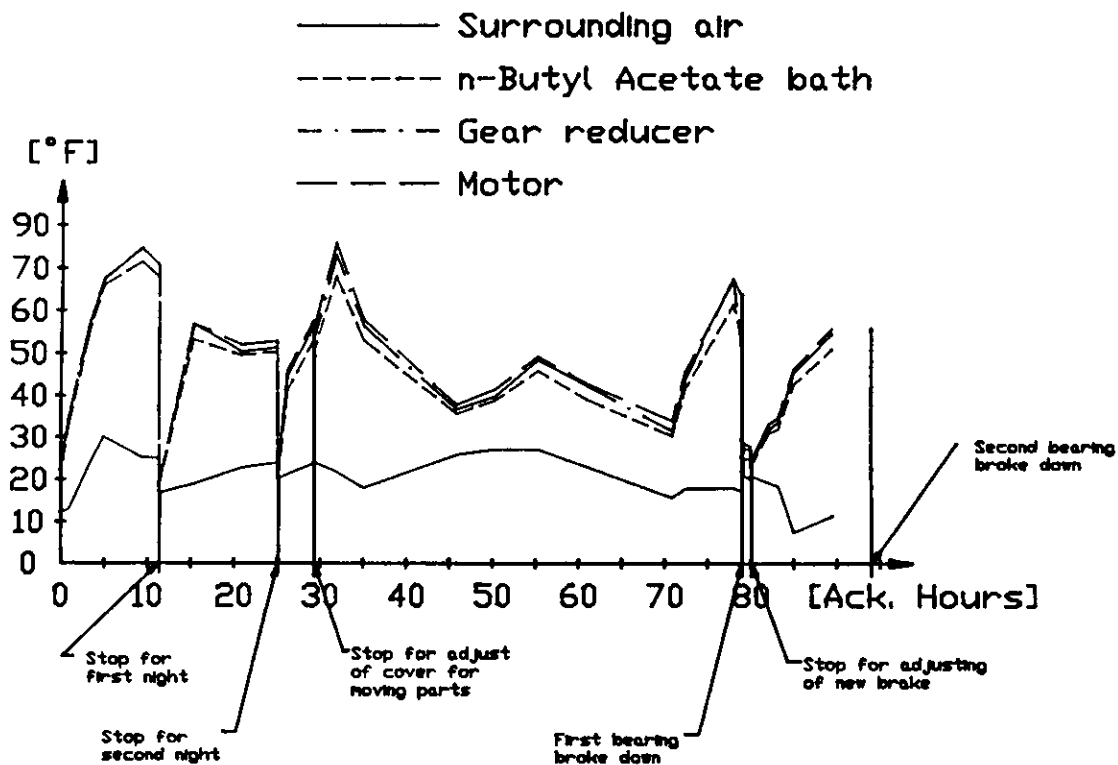
Figure 11. The temperatures during the experimental periods.

The outdoor temperature variations and the corresponding temperatures in the motor and reducer during the experimental periods are displayed in Figure 10. The outdoor temperature varied between -13.5°C and -2.7°C (Figure 11).

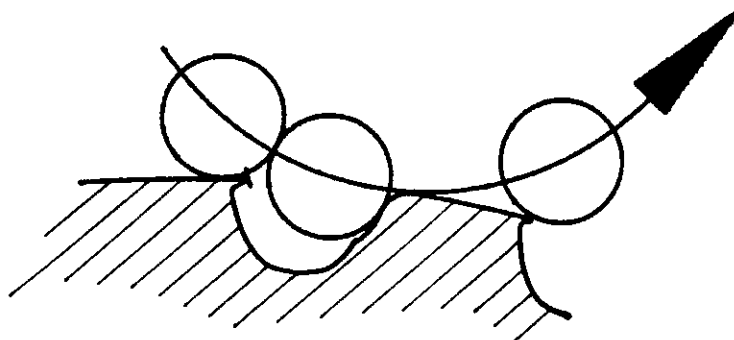
Figure 19. Sketch of the relative motion between the wheel and pins and the type of deformation on the teeth of the wheel.

The teeth on the circulate wheel have been deformed. The back edge of the tooth material hangs over the edge while the front edge has become more rounded (Figure 19 and 20). When a pin comes into engagement, it slides over the top of the tooth and deforms the back edge of the tooth. On some teeth small pieces of material

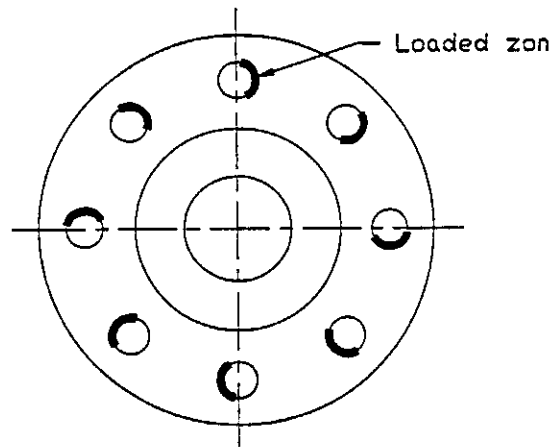
Figure 26. The location of the loaded zones on the carrier pins.

of the carrier pins are located correspondingly to the loaded zones of the circulate wheel (Figure 26). The shape of the carrier pins is slightly deformed. After 94 hours the original round shape is flattened in the loaded zone (Figure 27). The contact stresses are higher than the approximate elastic limit, 280 MPa, and some of the deformation could be plastic while some deformation probably is due to removal of

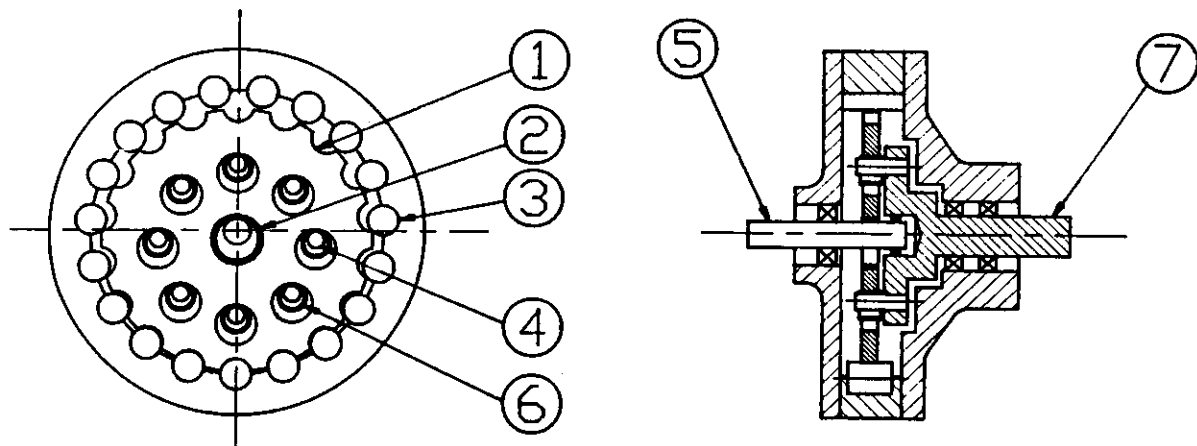
Figure 1.1. The circulate reducer.

The circulate wheel, bushings and the internal pins are made from a high carbon (1%), high chromium (1.45%) bearing steel. The carrier pins are made from a low carbon chrome-molybdenum steel: 0.15% C, 0.75% Mn, 1.05% Cr and 0.22% Mo. The chrome-molybdenum ratio resembles that of steel SIS 2216 (Swedish Standard) with 0.15% C, 0.75% Mn, 1.0% Cr and 0.35% Mo. Steel SIS 2216 has a yield stress at about 280 MPa.

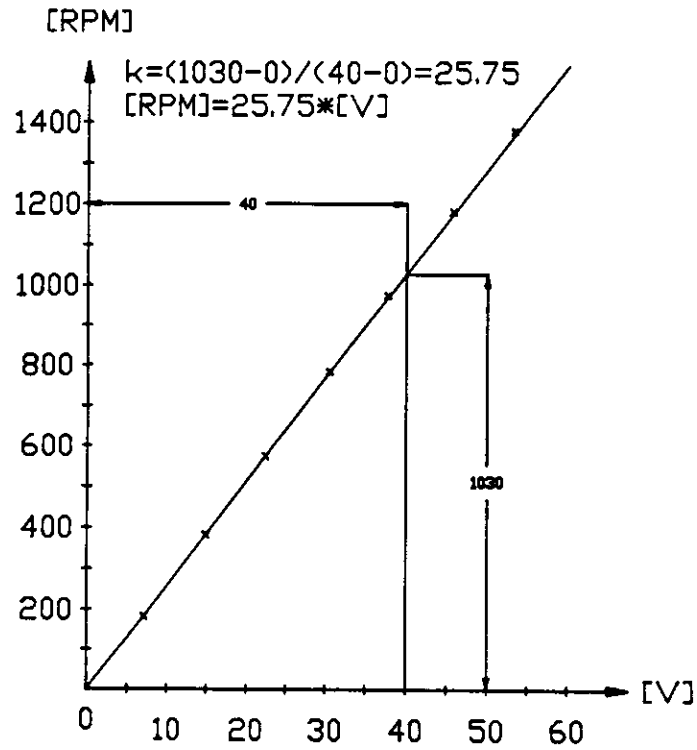
Figure 2.1. Calibration curve for the DC tachometer.

[V]	0	7.1	14.9	22.4	30.5	37.7	45.7	53.3
[RPM]	0	183	382	575	785	974	1181	1379
[RPM]=k*[V]	0	182.8	378.5	576.8	785.4	970.8	1176.8	1372.5

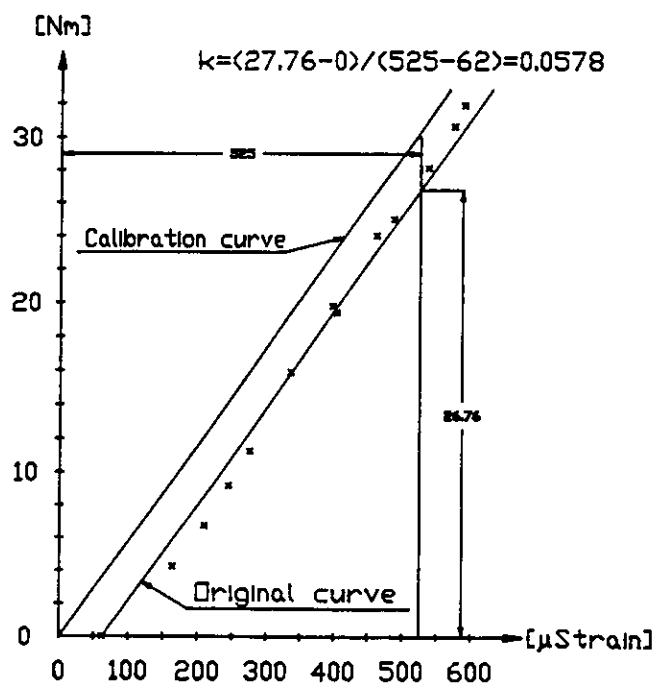
Figure 2.2. Original measuring curve and calibration curve for the strain indicator.

* [Nm]=0.0578*([μStrain]-62)

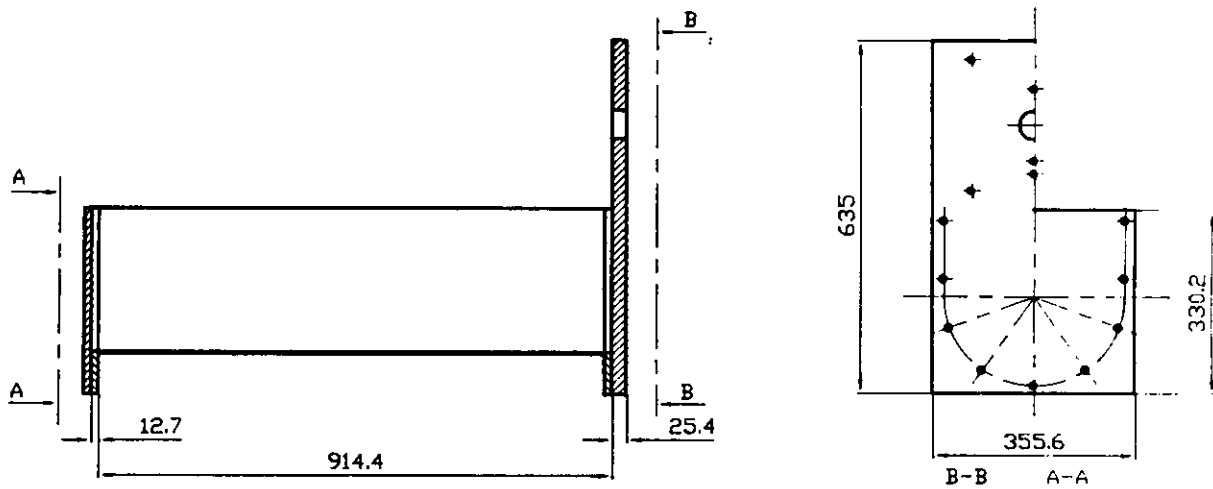
Figure 3.1. The trough with end pieces.

The container is an 18-inch-long trough made from 1/8-inch-thick steel plate. The thickness makes the trough torsionally stiff. Each end of the trough is open so that different end pieces can be used for other experiments. In this experiment we used two different end pieces, the first was a 1/2-inch-thick steel plate. The second one, where the brake is located, was made of a 1-inch-thick steel plate (Figure 3.1). Four supports were welded to the bottom of the trough. The motor and gear reducer system was fixed to the supports with two hose clamps.

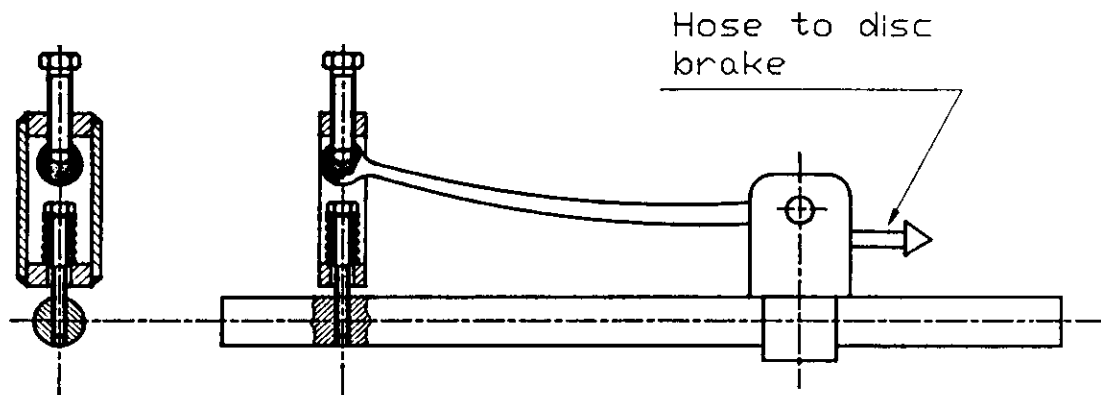
Figure 3.2. Motorcycle brake handle with spring.

The first method was to connect a motorcycle brake handle to the brake and load it with a spring (Figure 3.2). The problem with this method was that the handle leaked brake fluid. The leak caused the pressure in the hydraulic system to drop to almost 0 over a few hours and the load on the brake to decrease correspondingly.
