Mem. Natl Inst. Polar Res., Spec. Issue, **56**, 226–244, 2002

The EPICA deep drilling program

Laurent Augustin¹ and Adriano Antonelli²

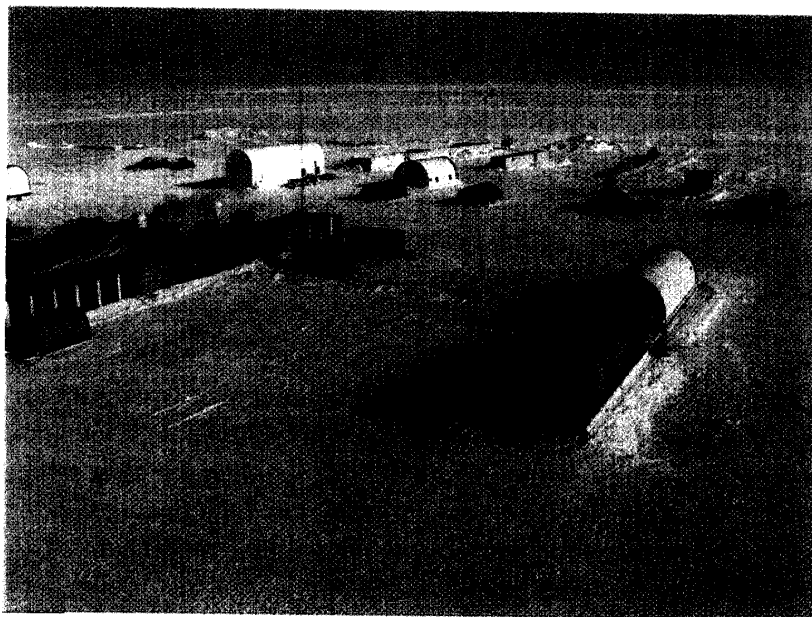
Fig. 1. Concordia summer camp.

buildings and tents were built on sledges in order to allow for easy movement of equipment and to prevent it from being buried (Fig. 1). A first line of containers was equipped with a few bedrooms, an emergency hospital, a kitchen and galley, toilets and a radio room along with the camp manager's office. A second set of containers contained the power plant for the summer camp with two current-generators of 150 kW each. Most of the accommodations, 200 m away from the common facilities, were located in four big tents with six beds each. Two long big tents were used as recreation room and offices, respectively. A big tent was equipped as a garage for vehicle maintenance. The EPICA program had its own drilling and scientific facilities: a workshop, a drilling tent, two buildings for scientific activities and a trench for the ice core storage.

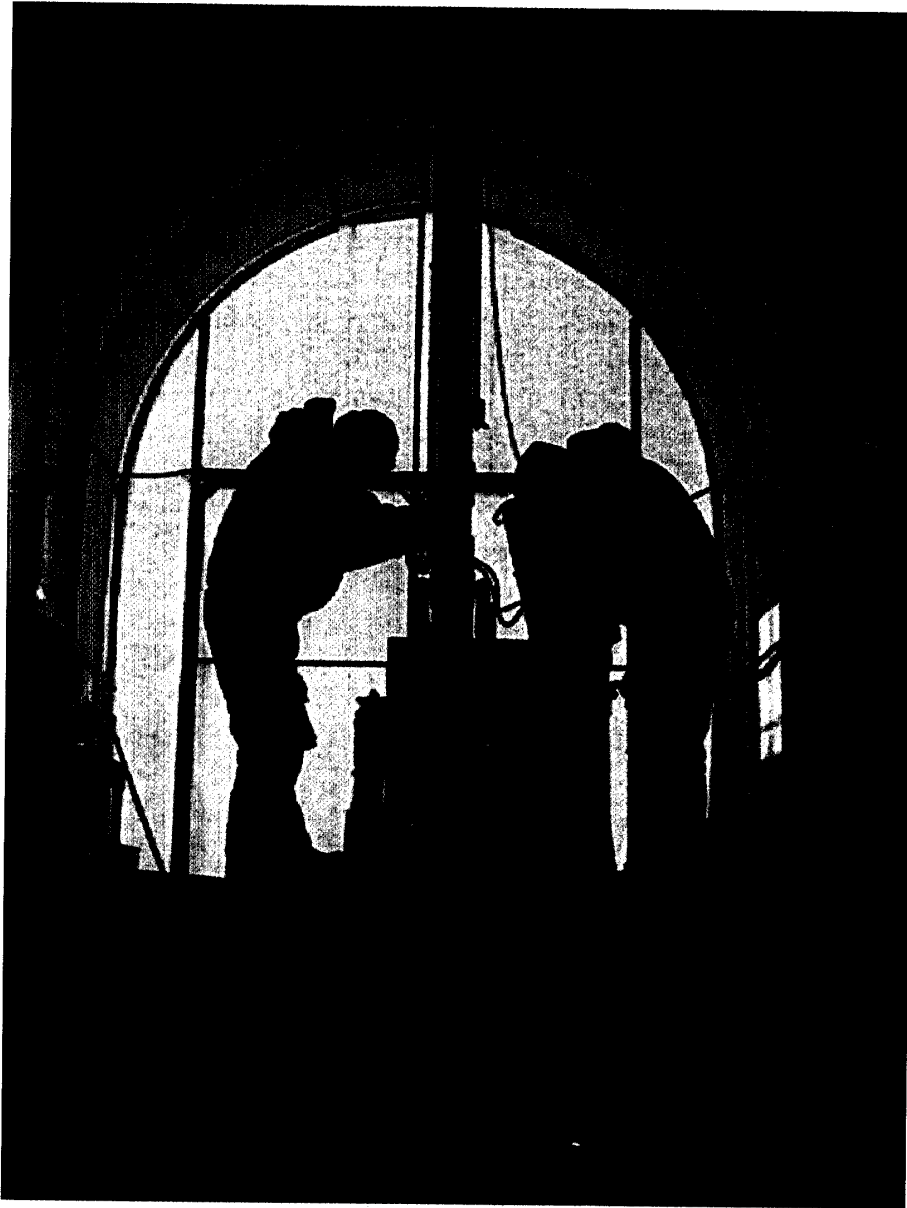
Fig. 9. Reaming activities.

We started the pilot hole 16 days after our arrival and 20 days later the new casing was in place (Fig. 8 and Fig. 9). Casing tubes were 20% heavier than the ones ordered in 1995. This did not have any consequences; we were able to put them down the hole using the tower and the winch from the deep drilling equipment. Putting down the twelfth tube we noticed a weakness in the winch motor. The winch was no longer able to hold the load properly (12 tubes = 7440 N load). This was the first sign of winch weakness.
